RIV938P/939P

ITEM CODE | 4439600/4843900

PRACTICAL GUIDE TROUBLESHOOTING

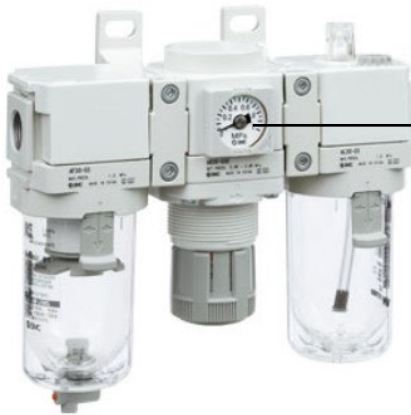
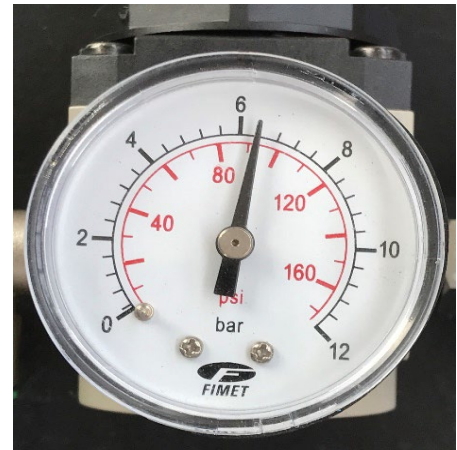
1.1 Not enough air, check the pressure, it must be between 6 and 6.5 bar.

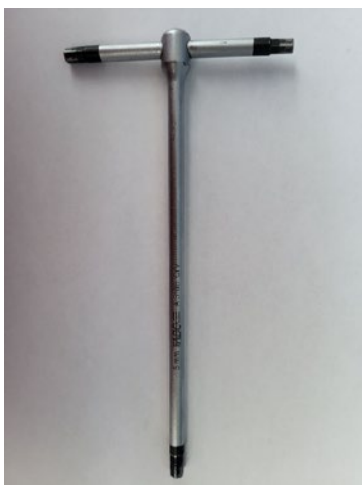
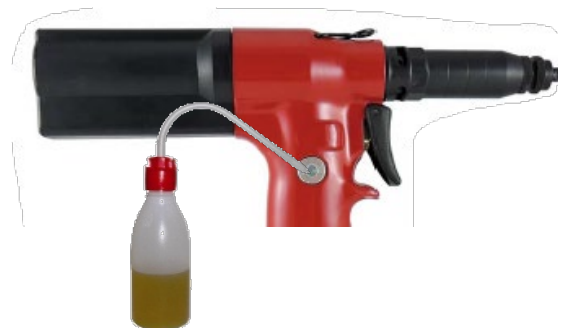
1.2 Not enough oil, top up by unscrewing the cap on the handle. Use a 5 mm hexagonal key.

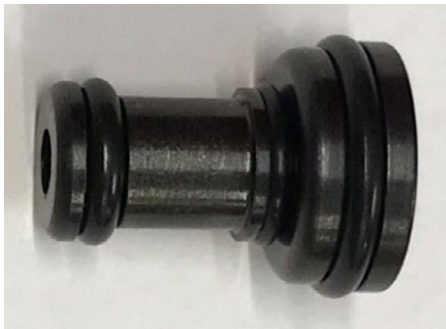
FIG.1

3.1 In the event of air leakage from the pressure switch, the most probable cause is broken OR rings, so check in particular those in the plunger **FIG.1** and check that they are not worn or broken, then check the OR rings in the chamber **FIG.2** replace the OR rings belonging to Kit Code 4154400.

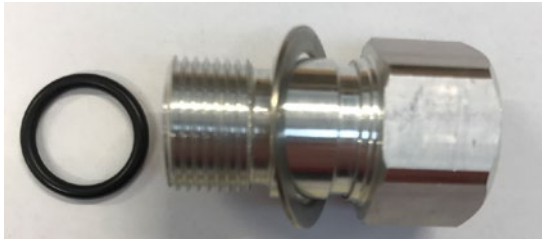
RIV938
Complete rod guide kit
code **4157300**

- 4.1** If there is air/oil leakage between the handle and air body, it is likely that the O-ring or oil seal in the piston rod guide is worn. or the oil seal in the piston rod guide. Replace the stem guide completely code **4157300** (for RIV938) and code **4647600** (for RIV939).

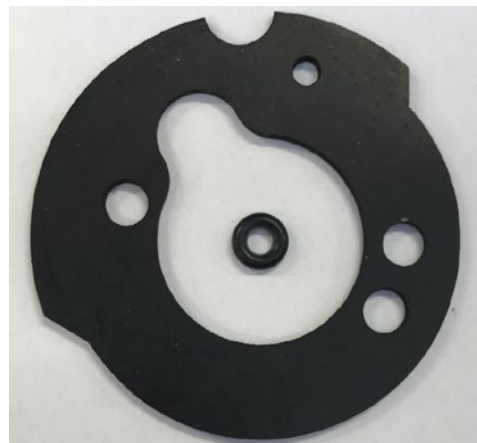
Flat gasket kit + OR
code **4152300**

- 4.2** If there is air/oil leakage between the handle and air body, it is likely that the O-ring or flat gasket on the air body is worn. Replace the O-ring and flat gasket completely Kit code **4152300**.

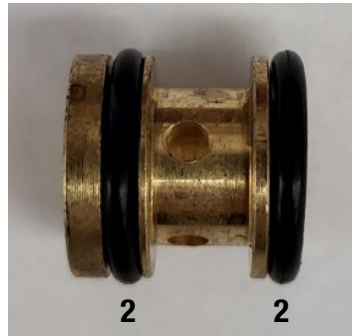
5.1 If there is an air leak from the button, it is likely that one of the two OR rings (2) on the cage FIG.1 is worn or broken. two O-rings (2) on the cage FIG.1. Replace the OR rings of the push-button KIT using the OR rings of KIT code 4151200.

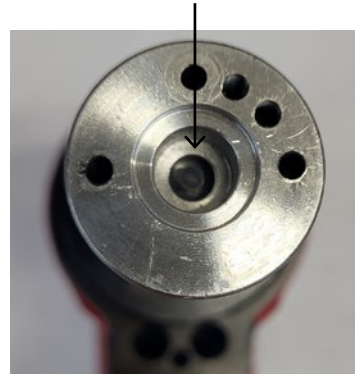
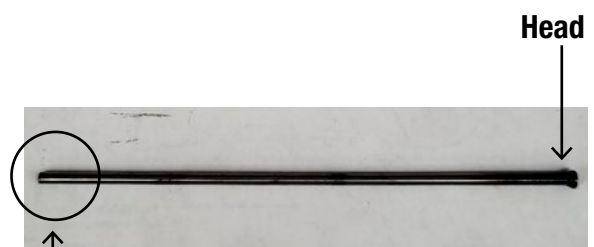
CASE 2)

Rod too long, does not allow the ball to close the air passage..

Lower the rod on the opposite side of the head until the ball is properly seated.

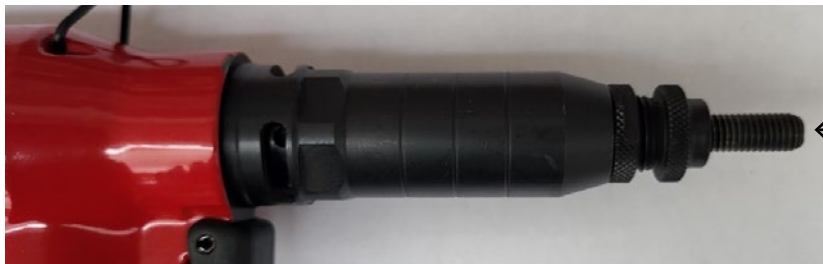
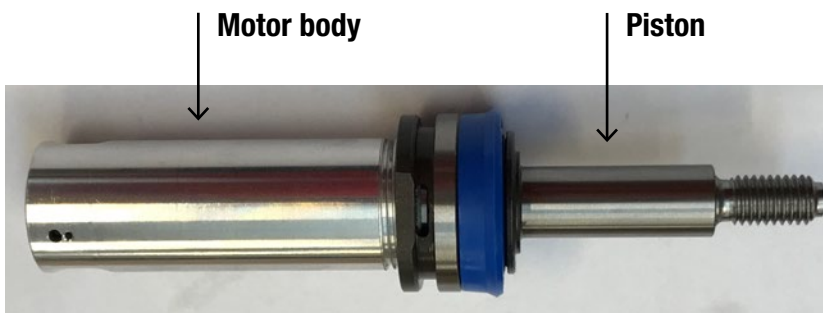
If the tie rod is blocked, it means that the whole assembly is not rotating and not working properly. The cause could be that the drive unit is too tight.

Locked tie rod
does not rotate

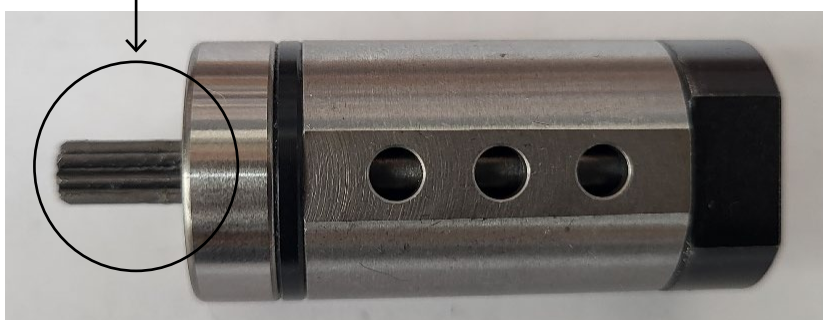
FIG.X

Part to be beaten very carefully and accurately
to loosen the motor unit.

Pull the piston out of the handle and unscrew the motor body from the piston, pull the motor assembly from the motor body and tap very carefully on the part indicated in the photo FIG.X, this very delicate step loosens the motor and makes the correct rotation take place.

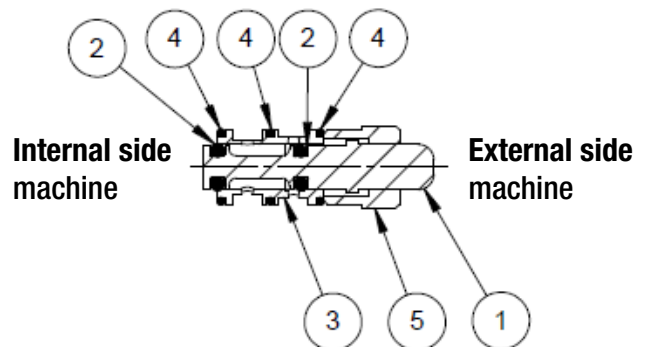
OR kit
Code 4156600

9.1 If, when air is applied, the tie rod turns continuously in unscrewing, it means that the O-rings belonging to the Quick Unscrewing Kit are broken or worn. To solve the problem, completely replace the Quick Unscrewing Kit code 4157000. If the components (not the O-rings) are in good condition, replace only the O-rings (OR Kit Code 4156600).

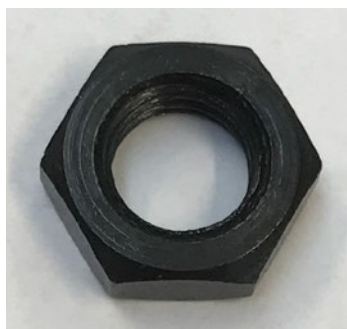
RIV938
Lock nut

If the tool after attaching the air does not screw the insert in correctly, adjust the lock nut screwed on the pivot pin to a distance of about 1.5 mm from the handle as shown in the photo below.

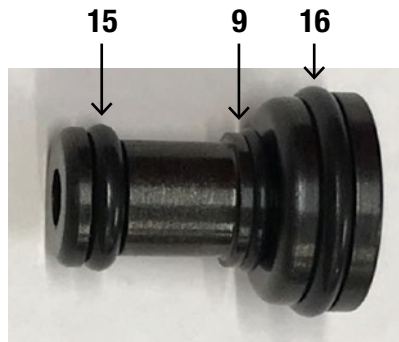
11.1 If pressing the push-button lever (to activate the machine cycle) causes the tool to unscrew without making a pull, check the pressure switch plunger and check that the OR rings (15, 9, 16) present are not broken or worn, in particular focus on the OR ring marked number 9. If they are broken or worn, replace the O-rings with the OR Kit code 4154400.

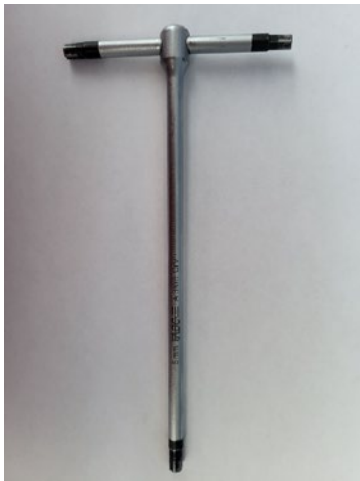
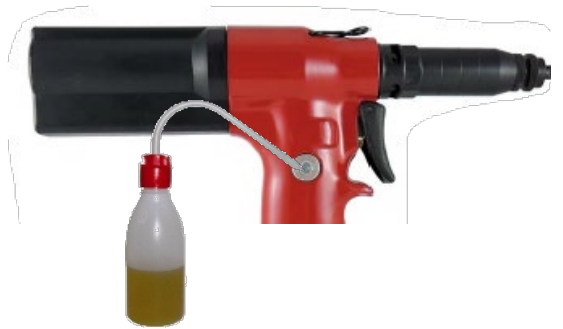
If the air inlet is 6 to 6.5 bar and the tool pulls but does not unscrew, top up the oil by unscrewing the plug on the handle. Use a 5 mm hexagonal key.

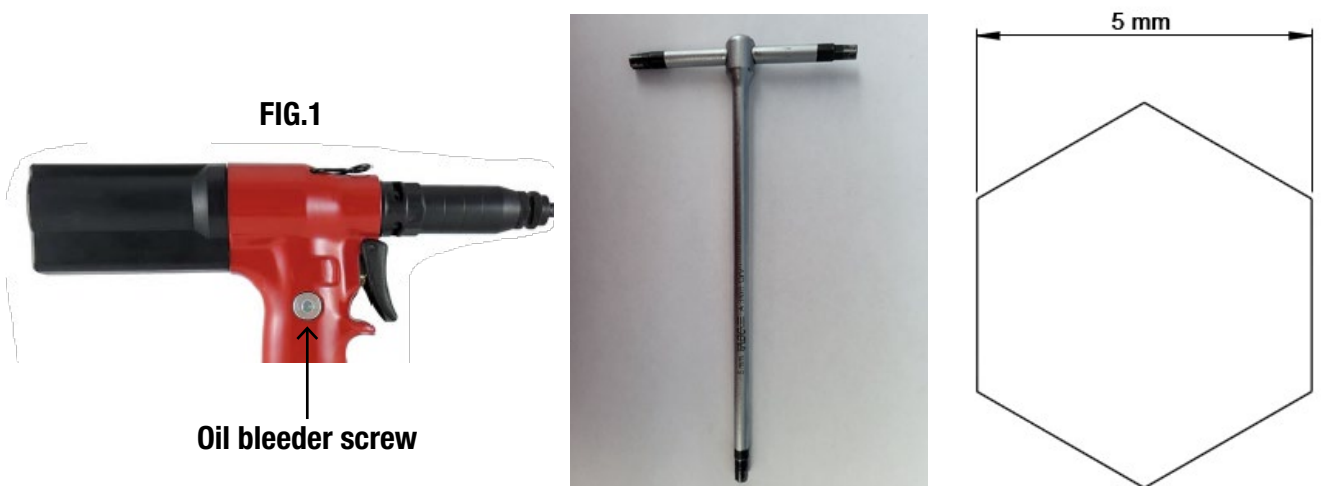
16.2 Air inside the grip chamber, bleed air/oil by unscrewing the screw at the front of the grip FIG.1. Use a 5 mm hexagonal key. When you have finished bleeding, tighten the screw firmly.

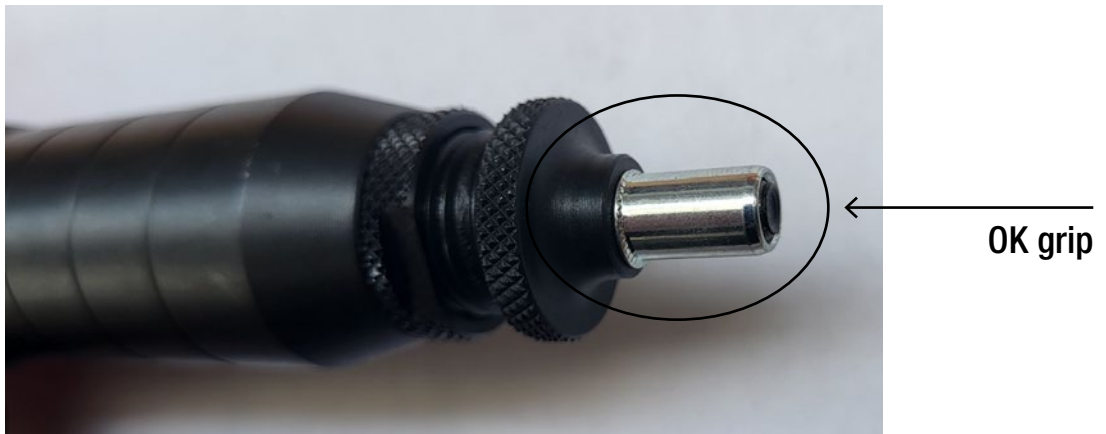
(FIG.1)

Check before use that the insert is correctly adjusted (see reference photo) socket ok (FIG.1).
Not OK grip (FIG.2) also causes the tie rod to break.
